**MAGMONT MINE TAILINGS DAM  
IRON COUNTY, MISSOURI  
MO 30917**

**PHASE 1 INSPECTION REPORT  
NATIONAL DAM SAFETY INSPECTION**

**APRIL 1981**

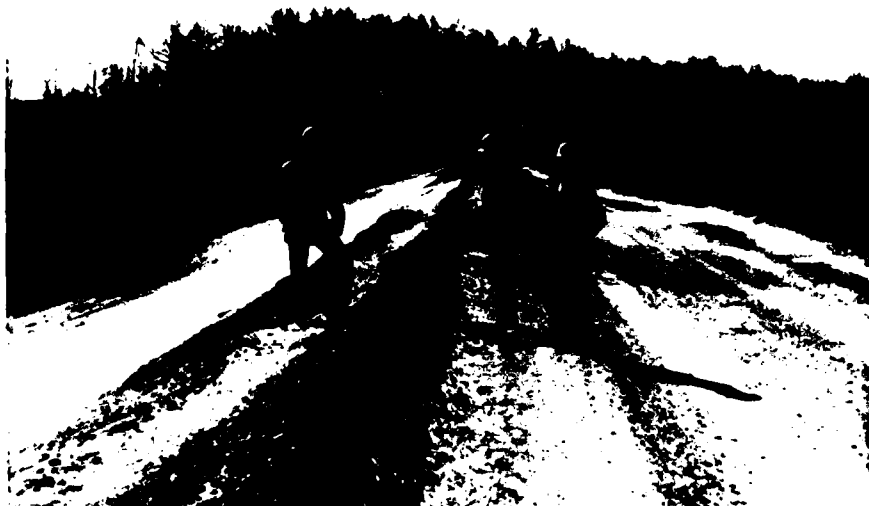
The road across the dam crest and the erosion control gravel berms on the shoulders of the road appeared to be in a good state of repair.

3. Gravel road on crest of dam. Note gravel berms along the shoulders of the road to prevent erosion on the slopes of the dam. Looking southwest from near the center of the dam crest.
